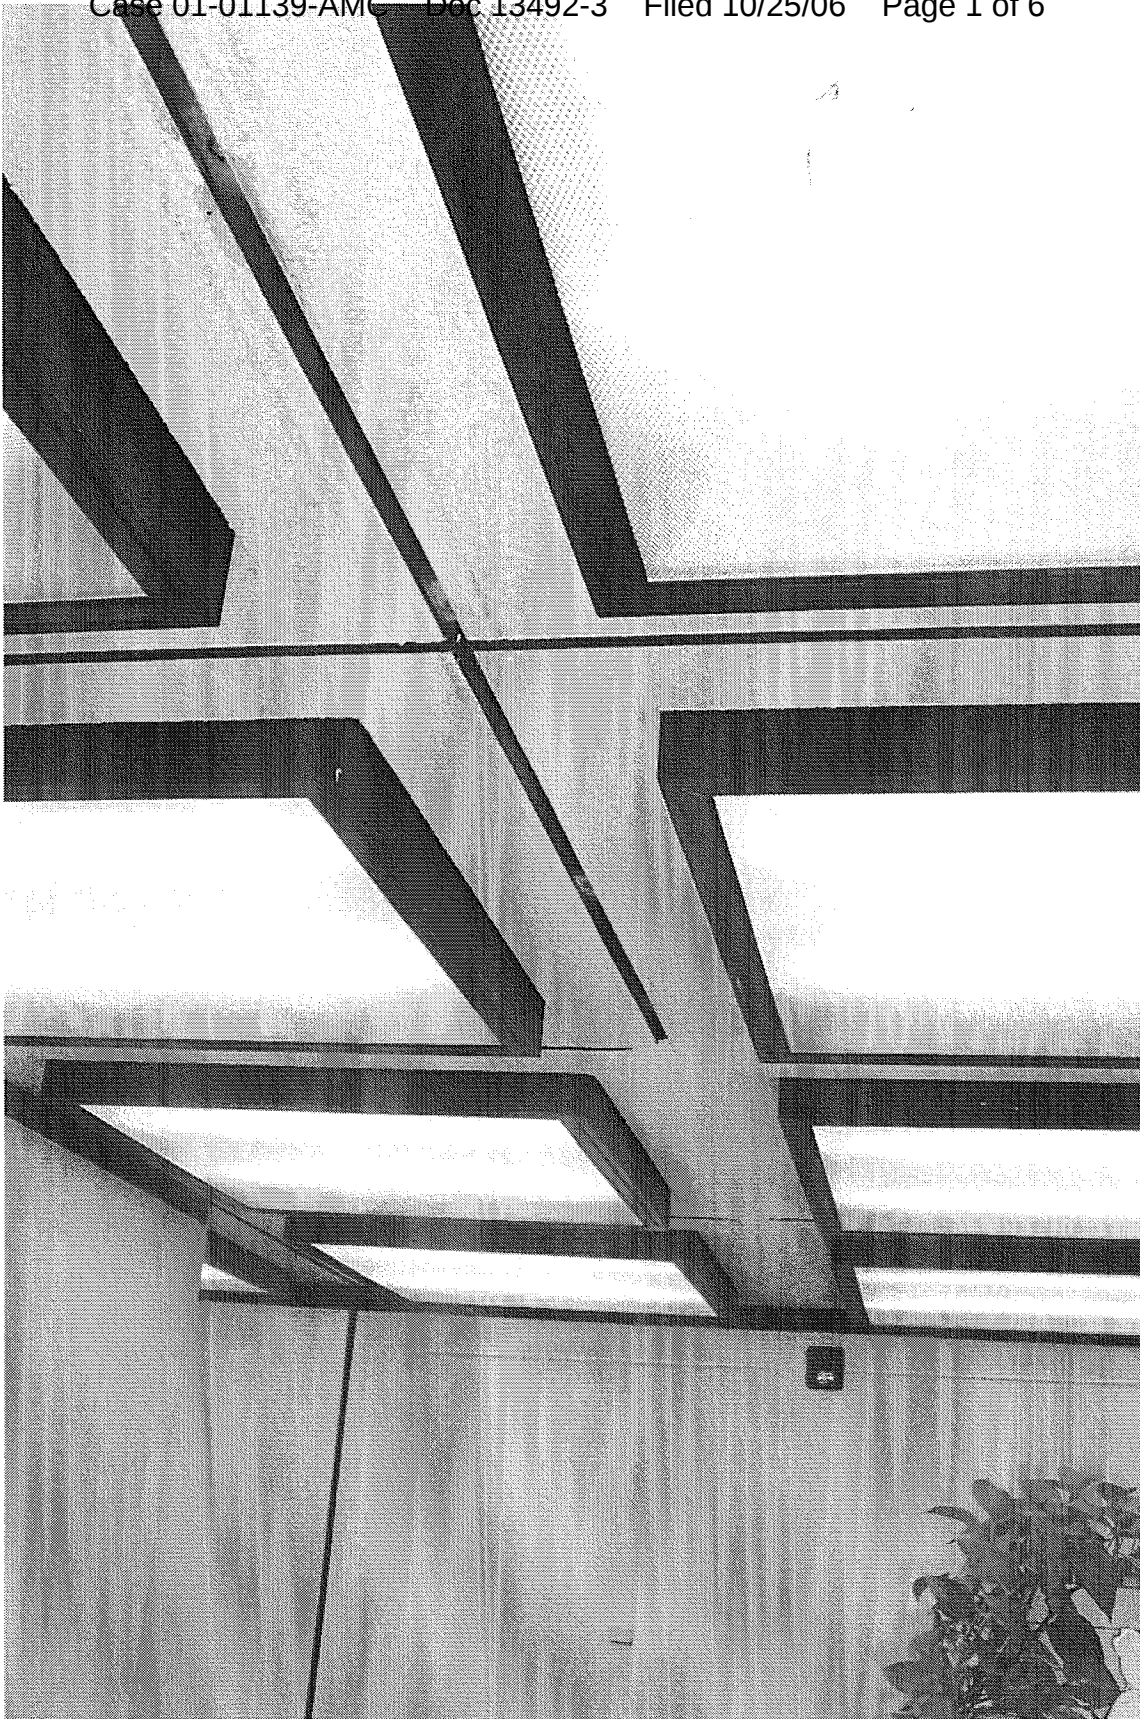
80. 4th floor, south hall outside Rm 404 - General view of damaged acoustical plaster (location of former wall)

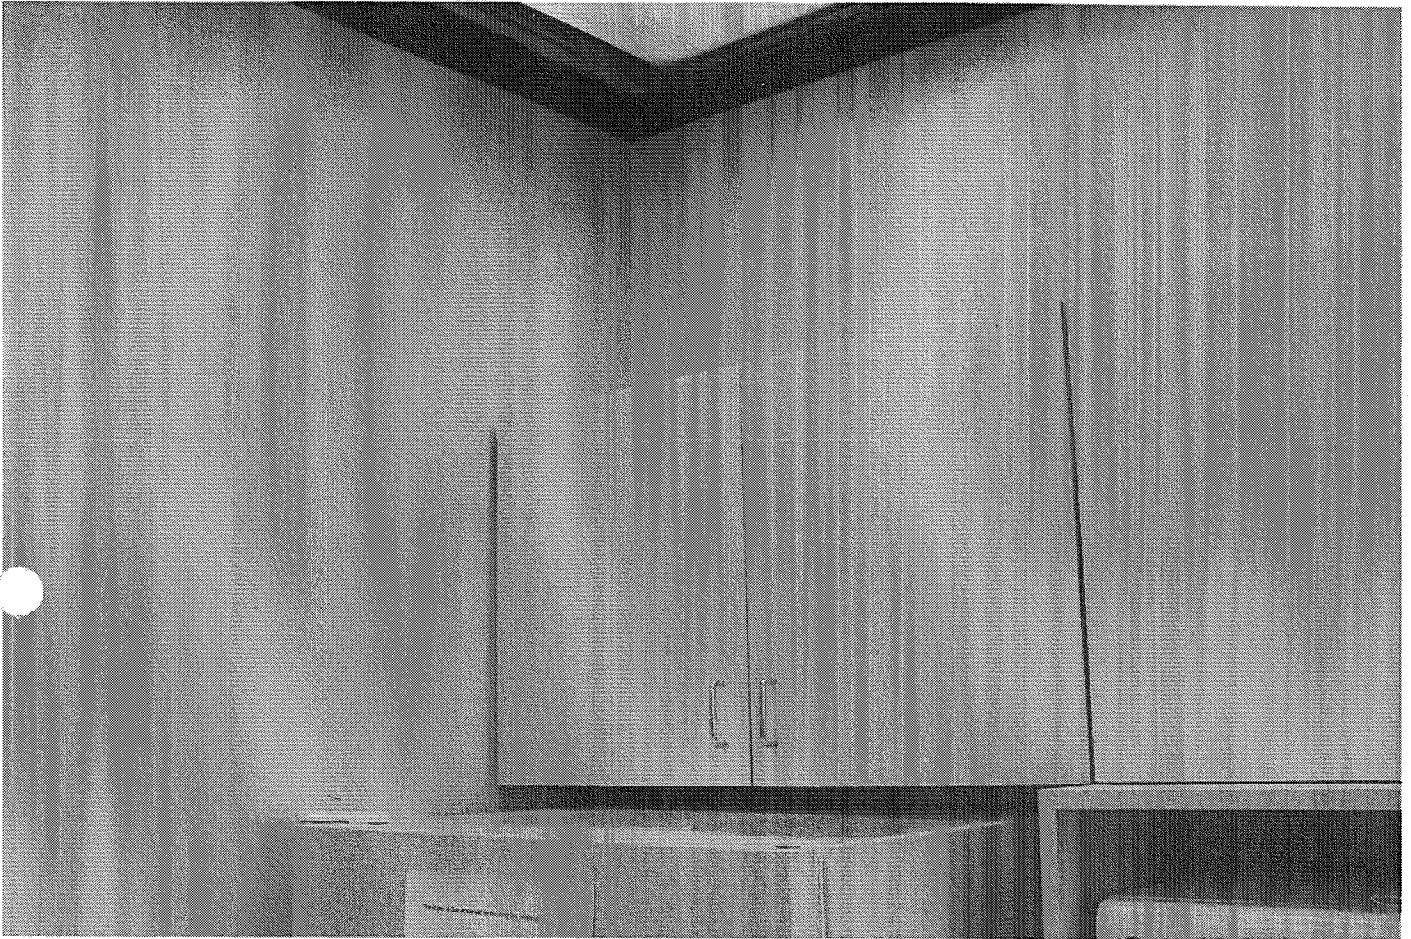
81. 4th floor, room 414 breakroom - General view of cabinets below acoustical plaster

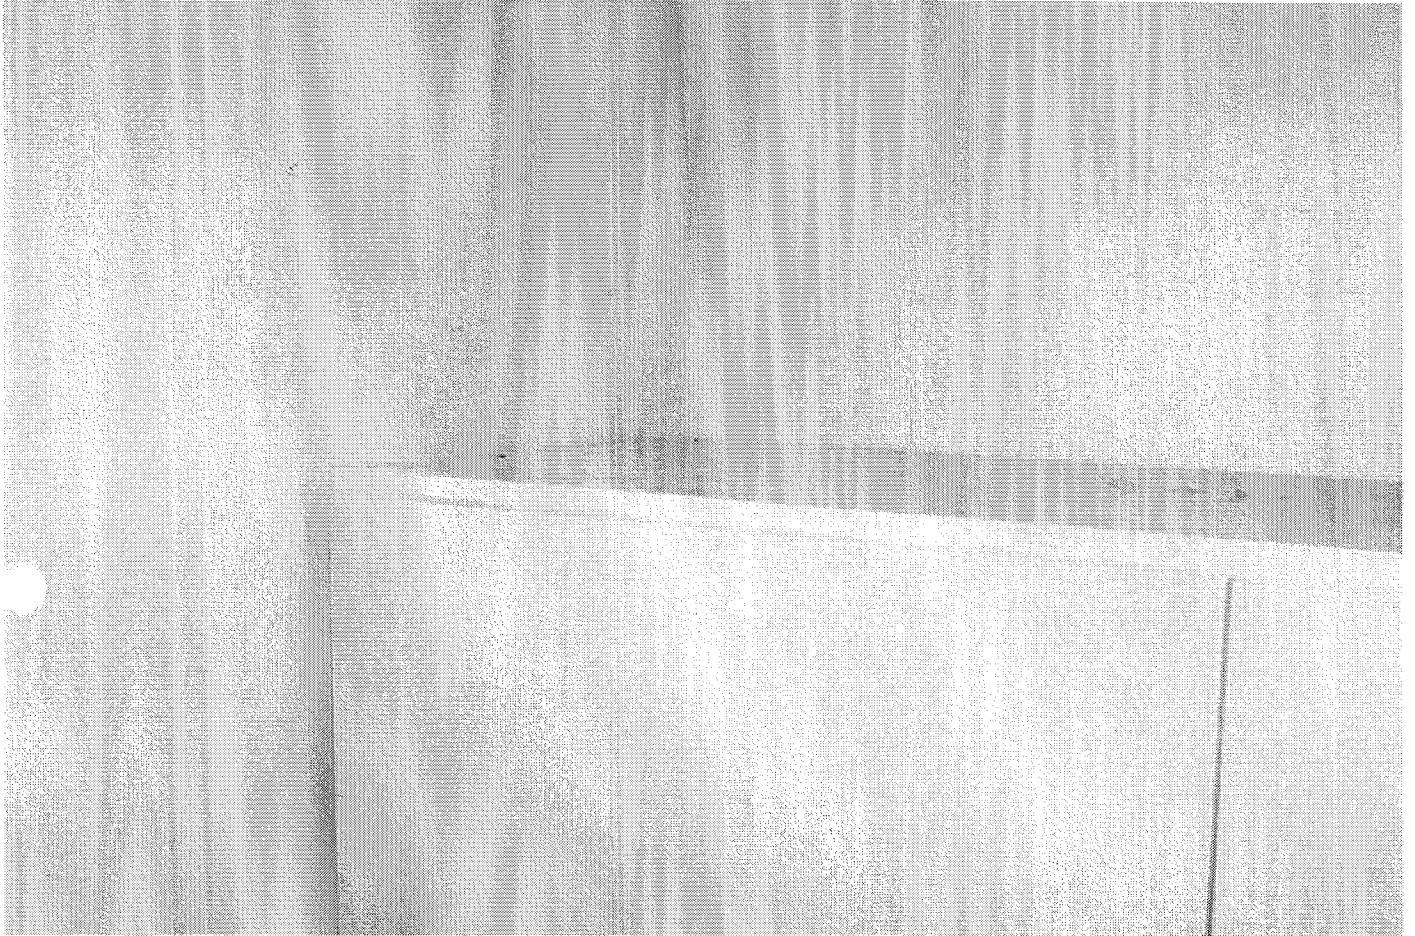
82. 4th floor, room 414 breakroom - Delaminated acoustical plaster on top of wall cabinets

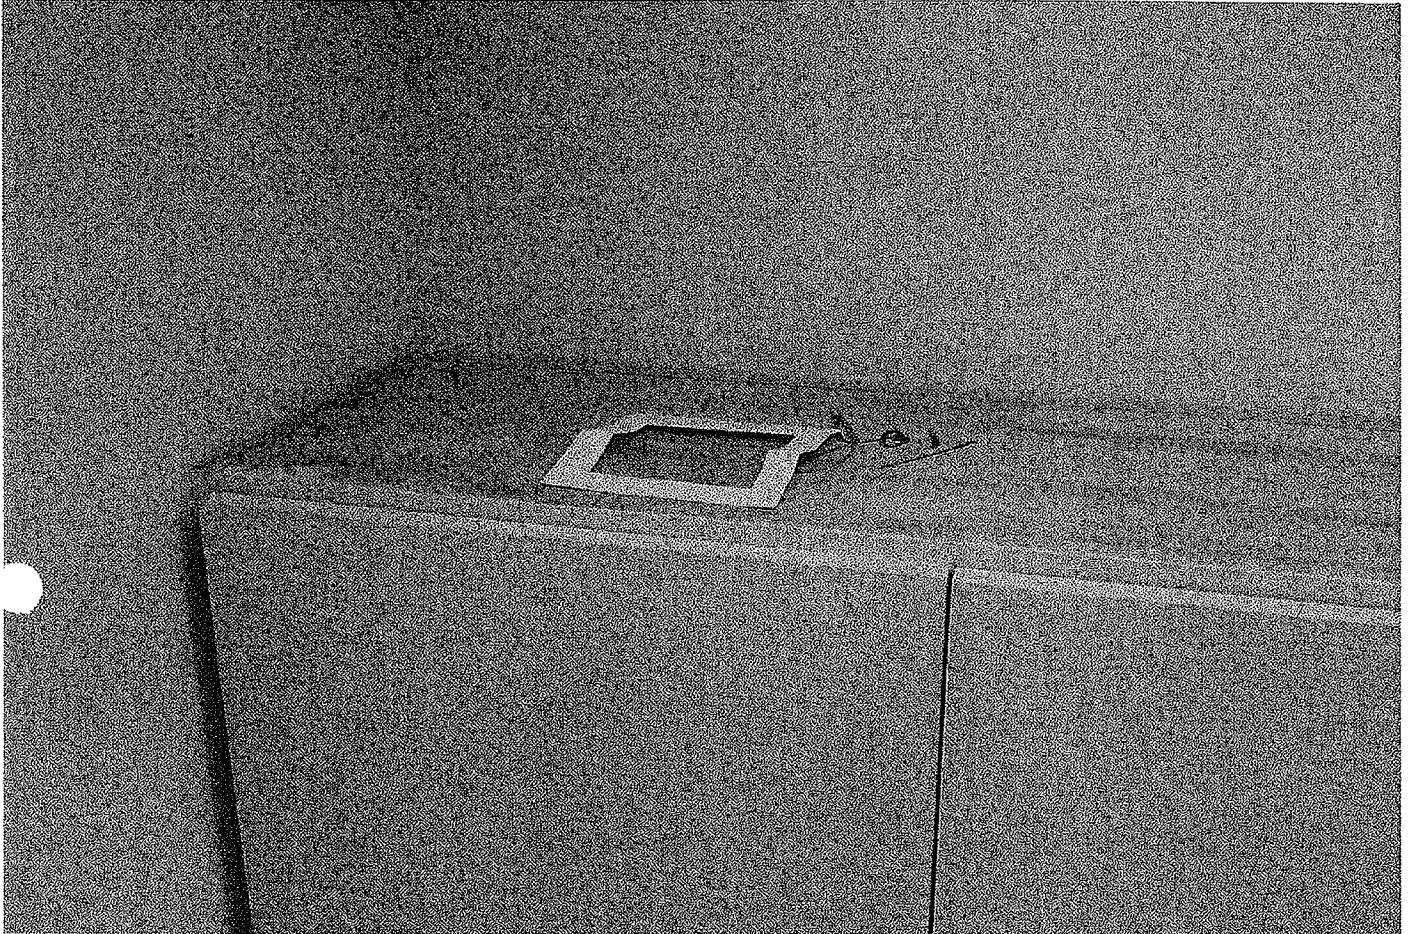
83. 4th floor, room 414 breakroom - Location of dust sample #2 -Top of wall mounted cabinets

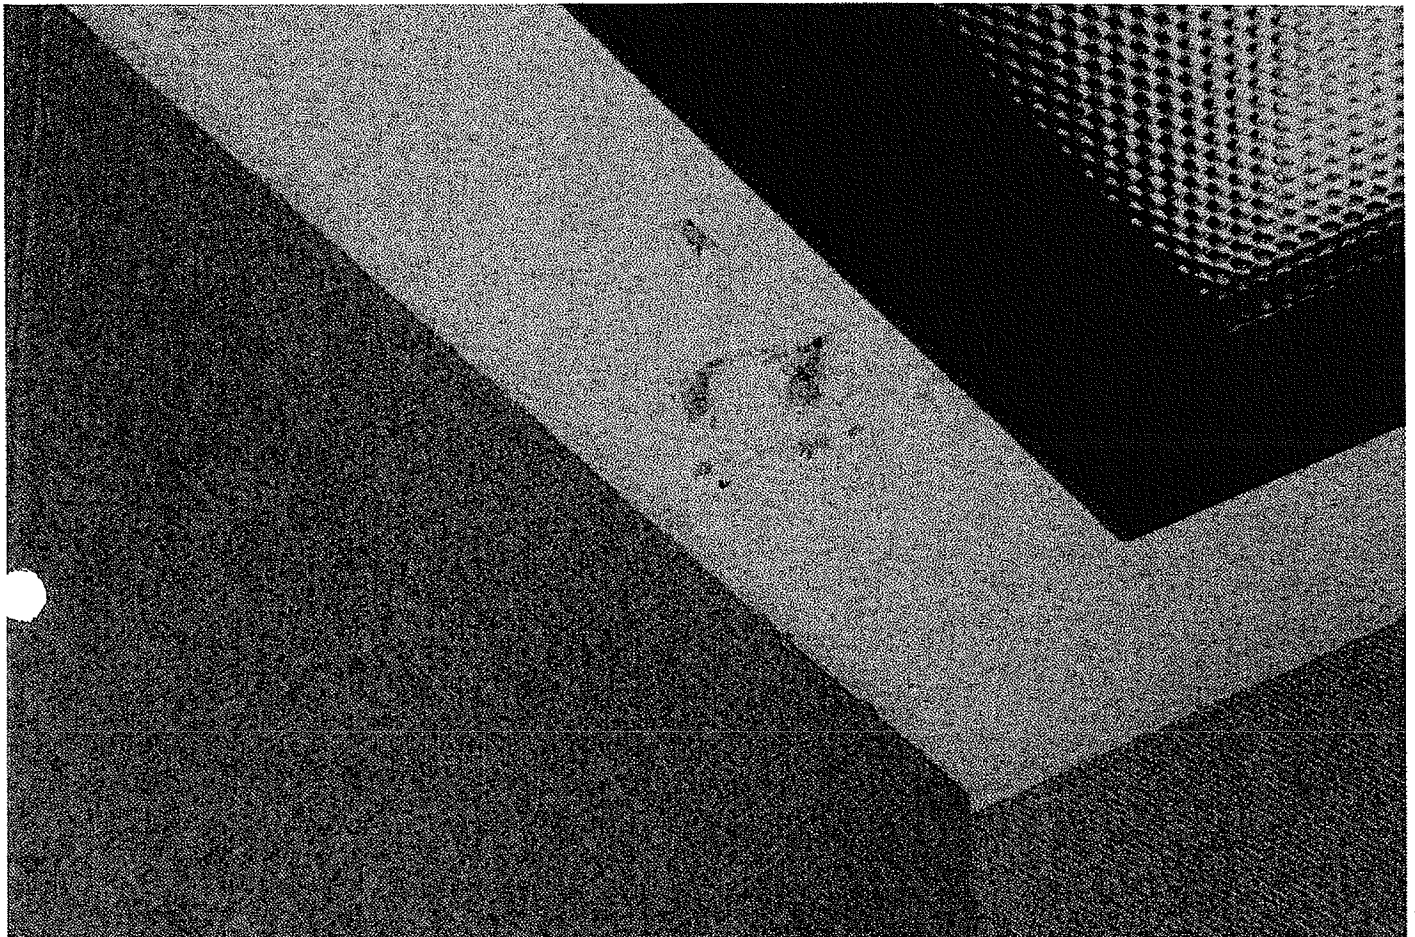
84. 3rd floor, outside room 311 - Impact damage to as at recessed light fixture

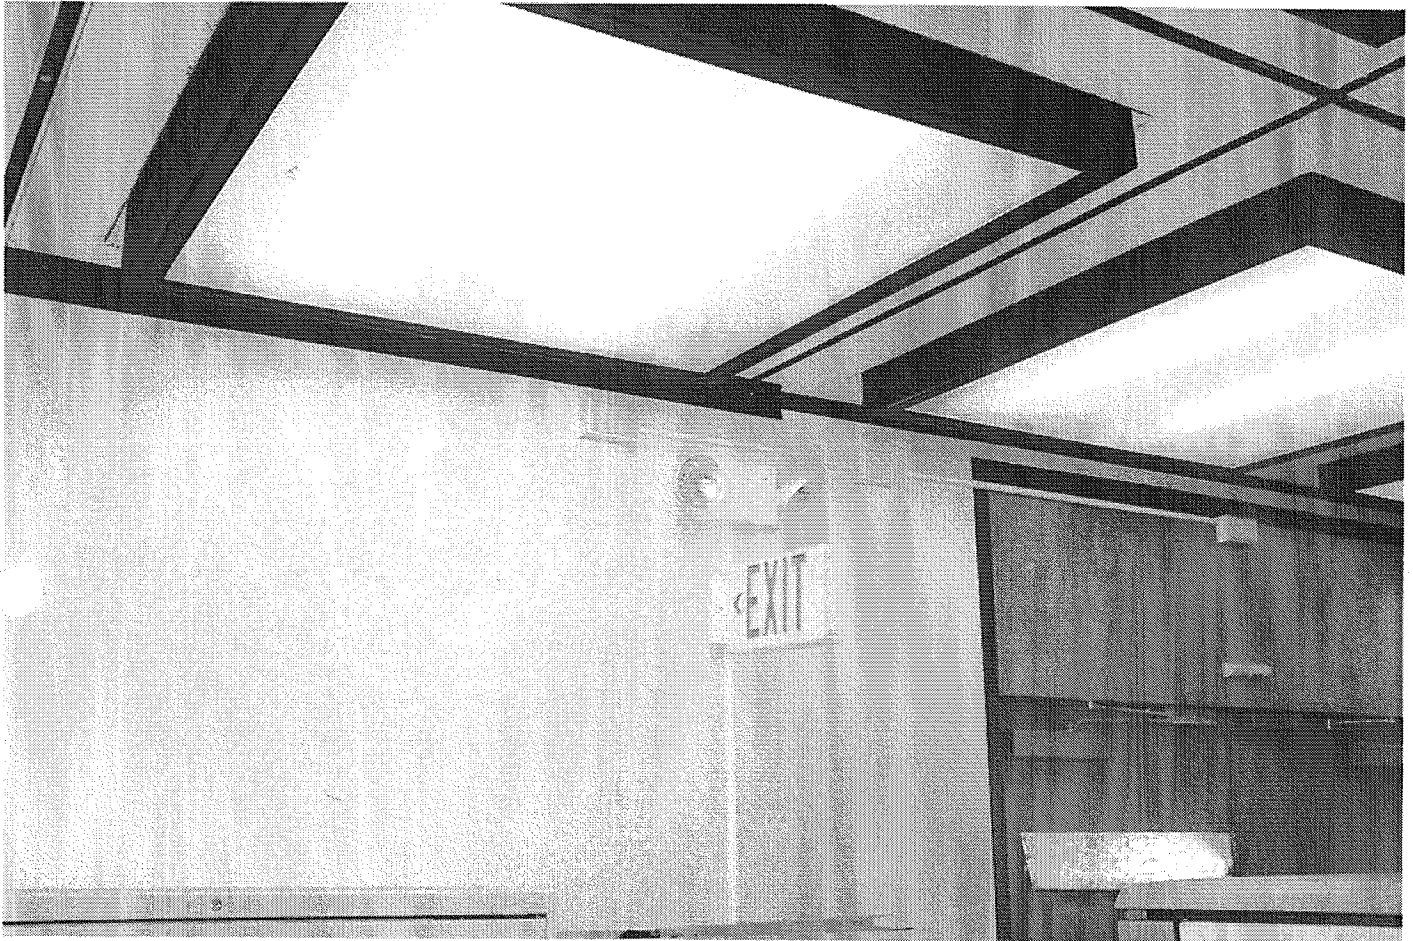
85. 3rd floor, outside room 311 - General view of acoustical plaster in west office area
